<b>POLARIS</b>			<h1>TECHNICAL SERVICE BULLETIN</h1>		
Date: March 21, 2017		<h2>ATV</h2>		Bulletin Number: A-17-01-D Model Years: 2015 - 2016	
<input checked="" type="checkbox"/> <b>Safety Bulletin</b>		<input type="checkbox"/> Service Bulletin		<input type="checkbox"/> Service Alert Fax	
Distribution: <input type="checkbox"/> Owner/Principal <input type="checkbox"/> Service Manager <input type="checkbox"/> Sales Manager <input type="checkbox"/> Parts Manager <input type="checkbox"/> Technicians <i>This Service Bulletin is located at <a href="http://www.polarisdealers.com">www.polarisdealers.com</a></i> <small>-Confidential and Proprietary-</small>

**2015–2016 Sportsman 1000 1-Up Thermal Protection Update**

Some model year 2015–2016 Sportsman 1000 1-Up models were manufactured with an exhaust manifold side panel that may contact the exhaust manifold. The resulting contact between the exhaust manifold side panel and exhaust may pose a fire hazard.

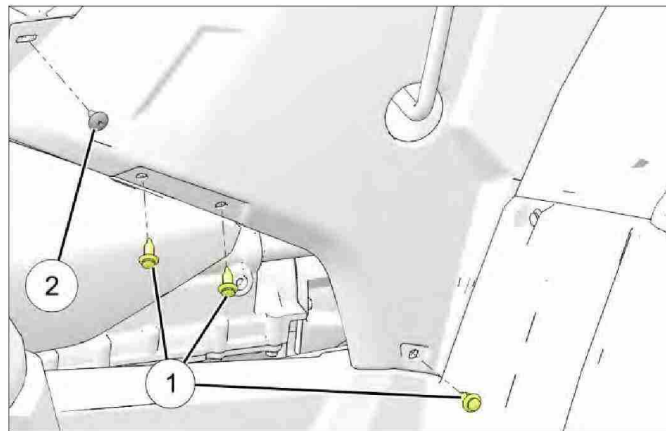
1. Remove the seat.
2. Using multi-function pliers and a T-27 Torx driver, remove the three Tuflok fasteners ① and screw ② retaining the lower half of the right-hand upper side panel.

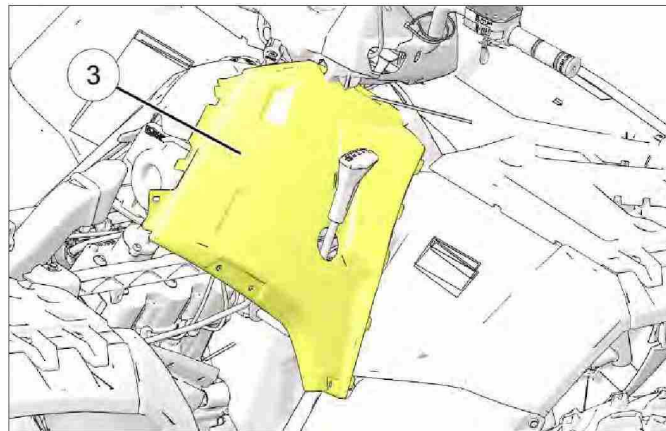
3. Remove the upper side panel ③.

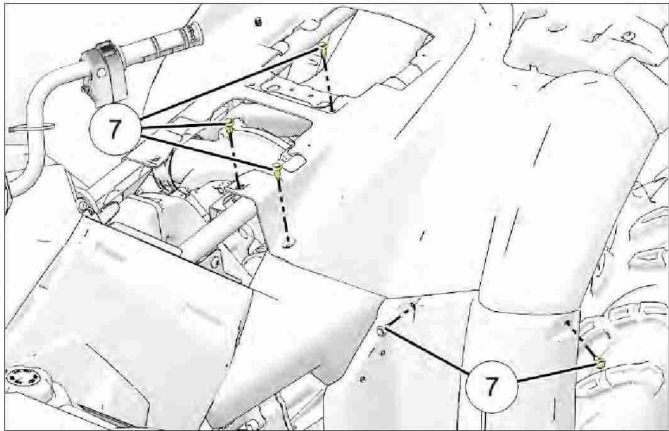
8. Using a T-27 Torx driver, remove the center four screws ⑧ retaining the rear cab assembly.

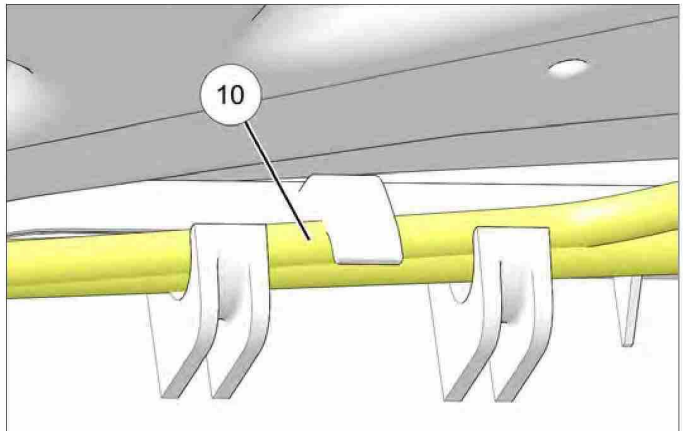
11. Remove the rear cab assembly ⑪.

Inspect the taillight wiring harness. If the convoluted tubing or reflective tape is damaged, take photos of the affected components and submit an ASK Polaris case for review by Tech Service.  
 Convoluted Tubing: 8360056-31  
 Foil Tape Wrap: 5814693

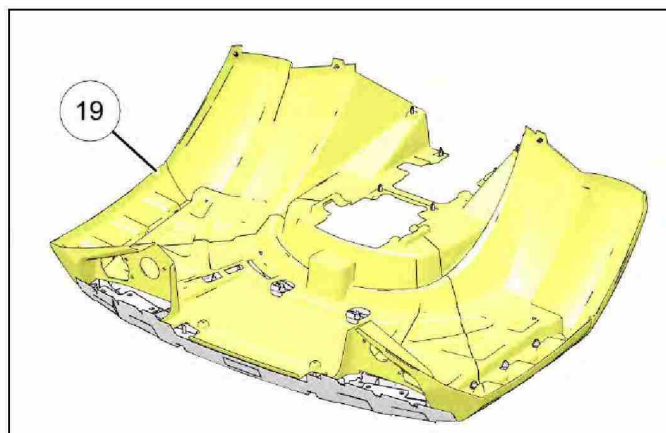
14. Inspect the rear cab ⑲.

If the rear cab ⑲ is deformed, take photos of the affected components and submit an ASK Polaris case.

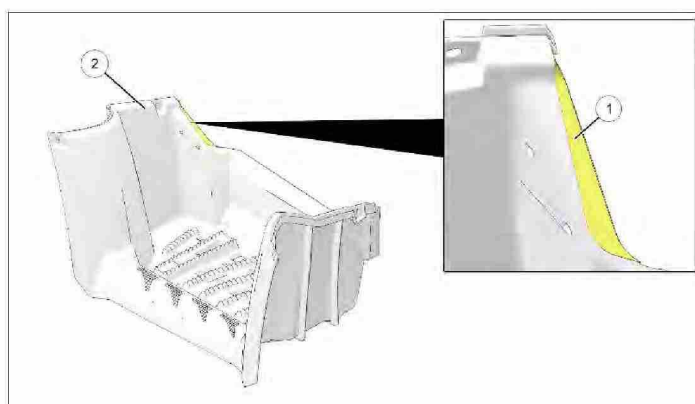
2. Place the provided template ① on the right-hand footwell ② as shown, then mark the perimeter of the template to outline the area to be trimmed with a paint pen.

Use the inside and back edges of the footwell to locate the template.

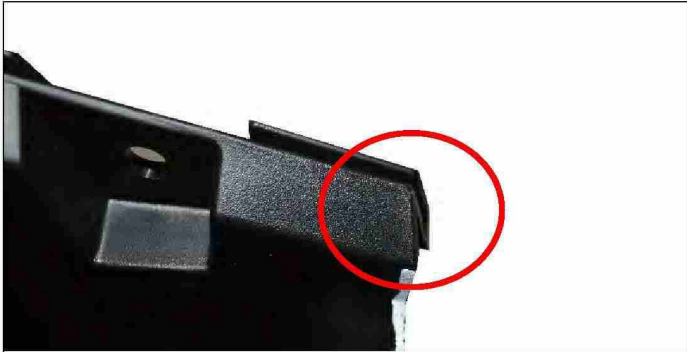
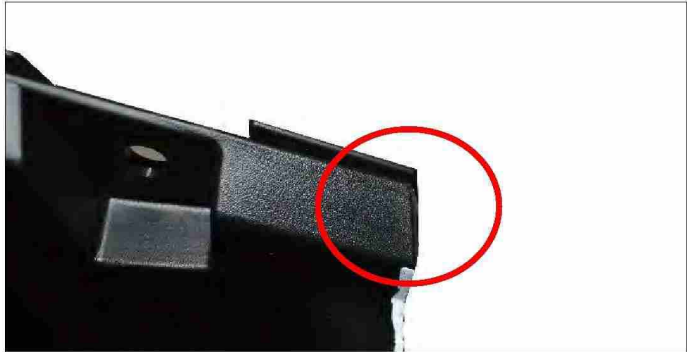
5. Using a DREMEL® with a two flute bit intended for plastics, a reciprocating saw or similar device, trim the footwell corner in line with the template (area circled in red shown in the **Before** and **After** images below).

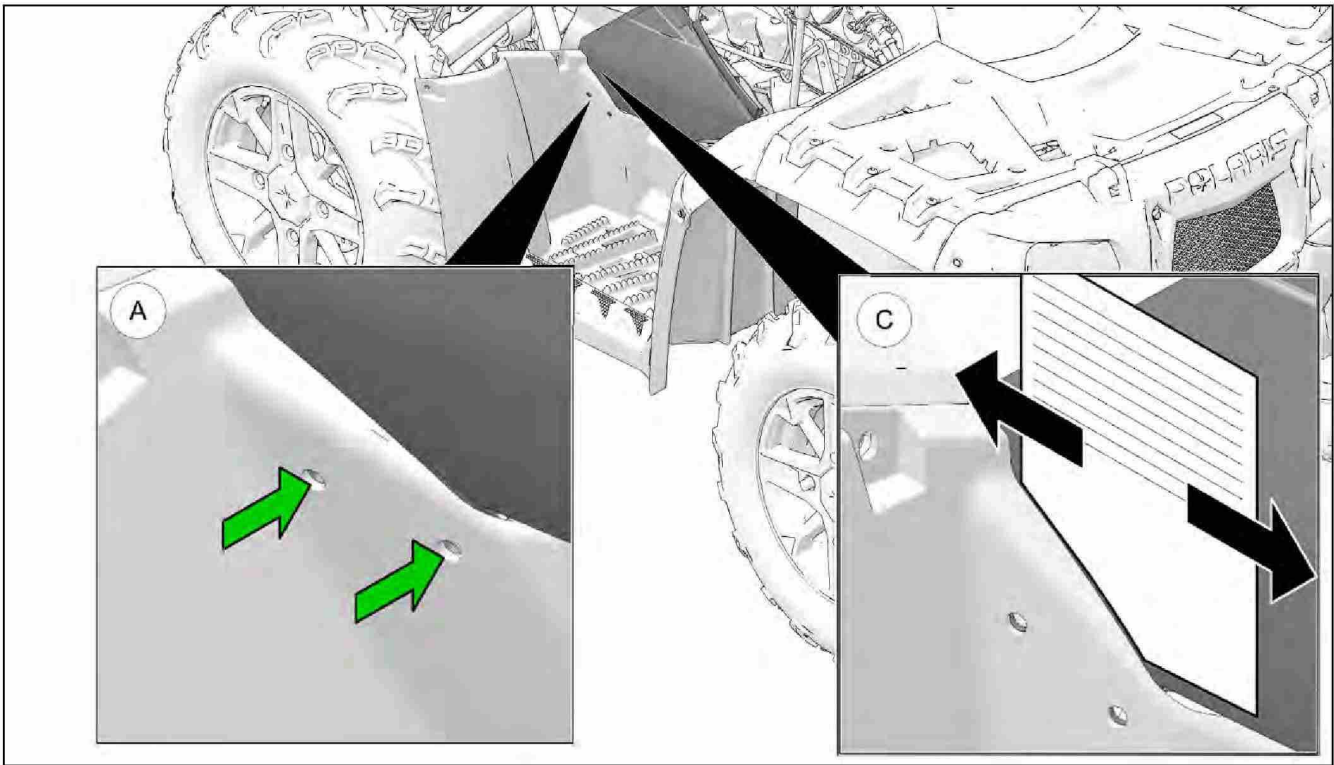
6. Test fit the new panel to verify the footwell area trimmed does not contact the exhaust manifold side panel when the lower mounting surface is contacting the footwell.
  - A. Align the mounting holes.
  - B. Press the exhaust manifold side panel against the footwell applying pressure at or near the holes.
  - C. Slide a piece of paper along the gap between the two panels.
    - If the paper slows or stops or the metal shield makes contact with the footwell, use a half-round file to trim the footwell to create a clearance gap between the components.
    - If the paper freely travels the length of the gap, and the metal shield does not contact the footwell, proceed to the audit and following steps.

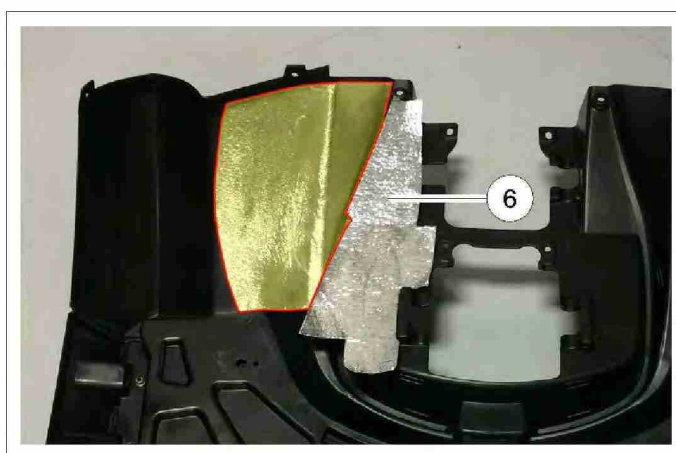
2. Install the rear cab heat shield foil (5814631) ⑥ on to the rear cab as shown.

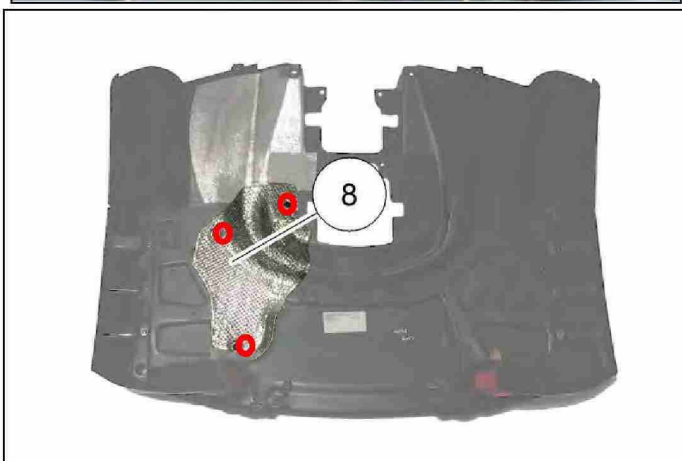
8. Align the new rear cab heat shield (5263209) ⑧ with mounting holes, and install the nylon plastic dart clips (7670090).

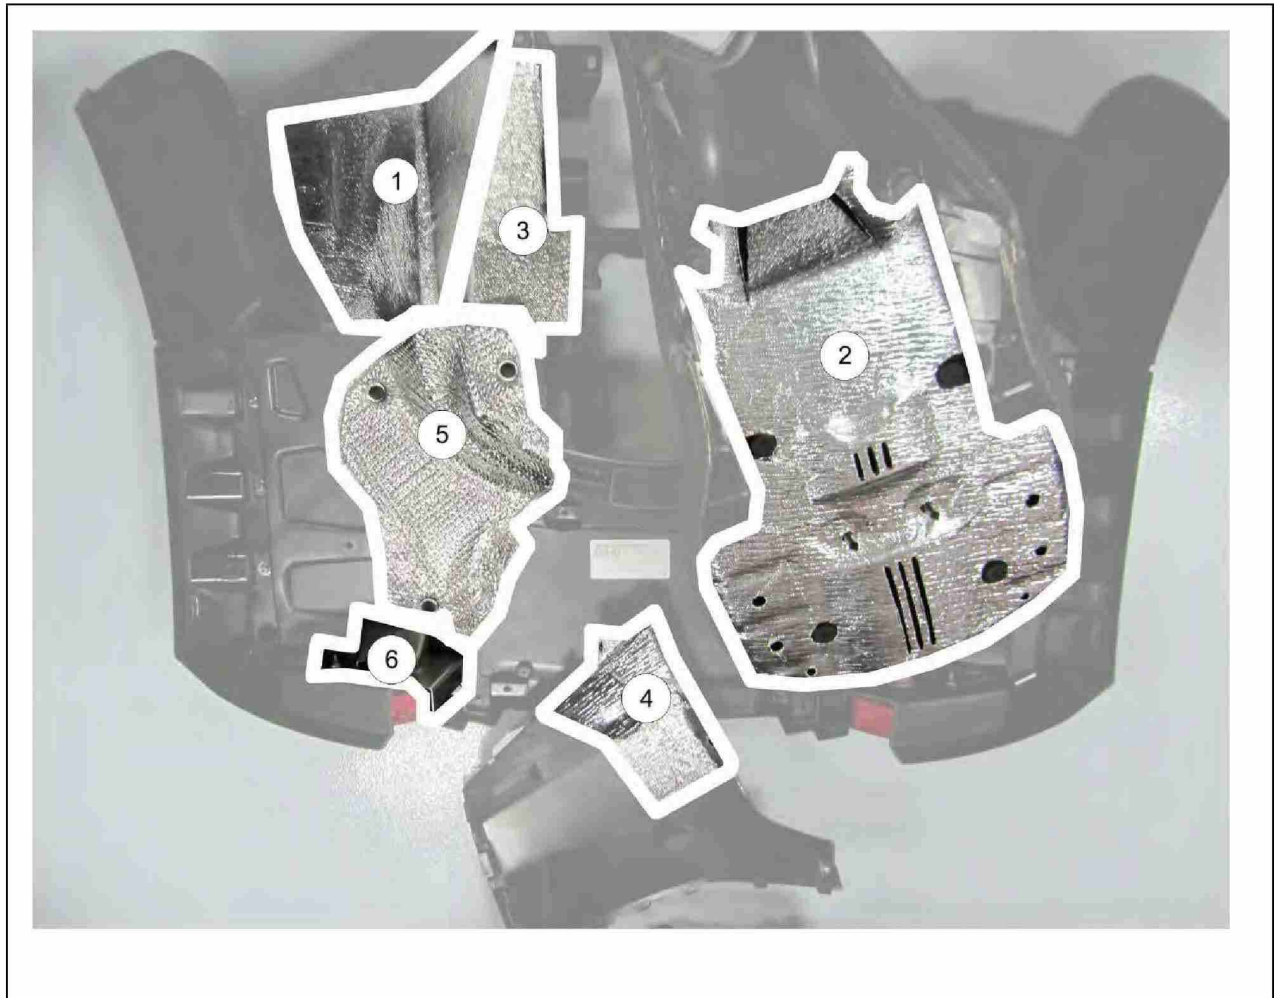
9. Take a picture of the cab, side panel, and seat so that all heat shields/foils on these components are visible. This is one of two pictures required to submit the warranty claim.

A secondary dealer representative must verify that all heat shield foils listed have been installed properly, and that the picture demonstrating this was taken.

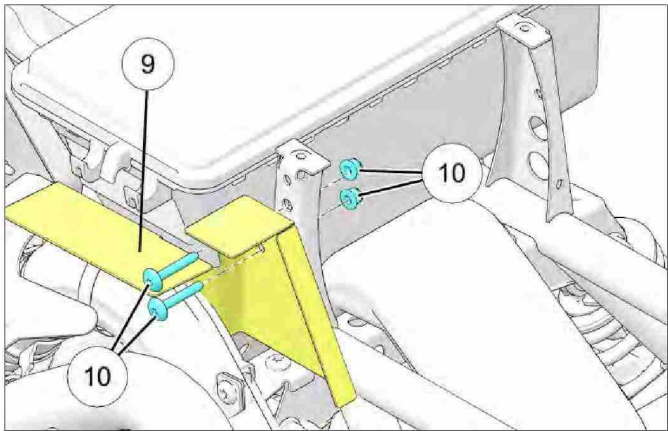
1. Align the rack support heat shield (5264561) ⑨ with the mounting holes on the rack support. Retrieve the T-40 bolts (7519650) and the nyloc nuts (7547274) from the kit and loosely install. Using a T-40 Torx driver and a 10 mm combination wrench, install the fasteners ⑩ that retain the rack support shield. Torque to specification.

<b>TORQUE</b>
Rack Support Heat Shield Fastener: <b>6 ft-lbs (8 Nm)</b>

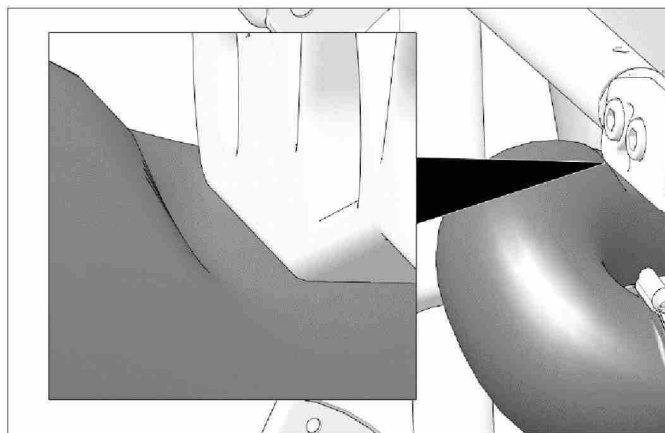
Notched portion of the rear of the rubber outlet duct ④ should contact the frame.

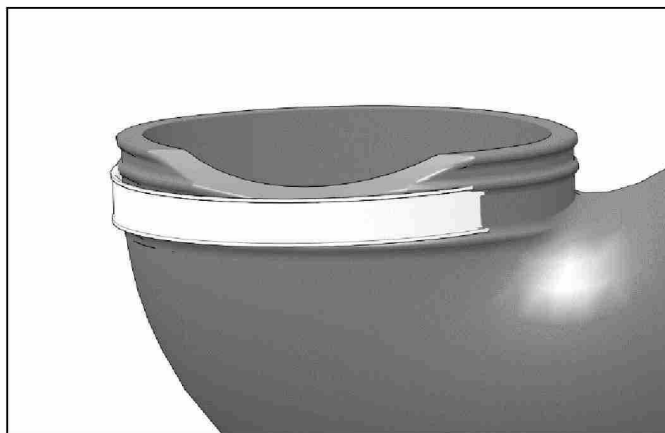
The lower portion of the rubber outlet duct is shaped to properly fit the clutch cover assembly outlet.

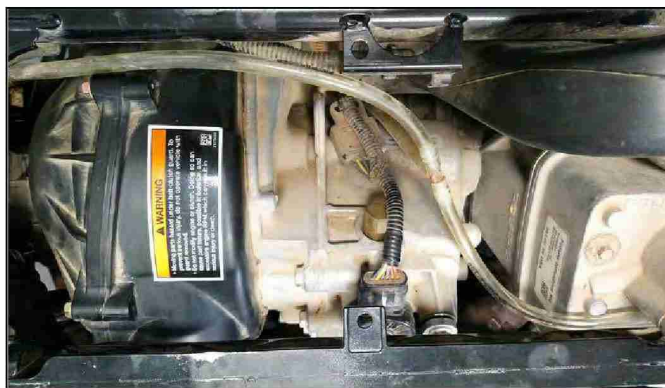
When installing the new clutch outlet duct, route the gear case vent line as shown. Ensure the gear case vent line is not pinched or kinked.

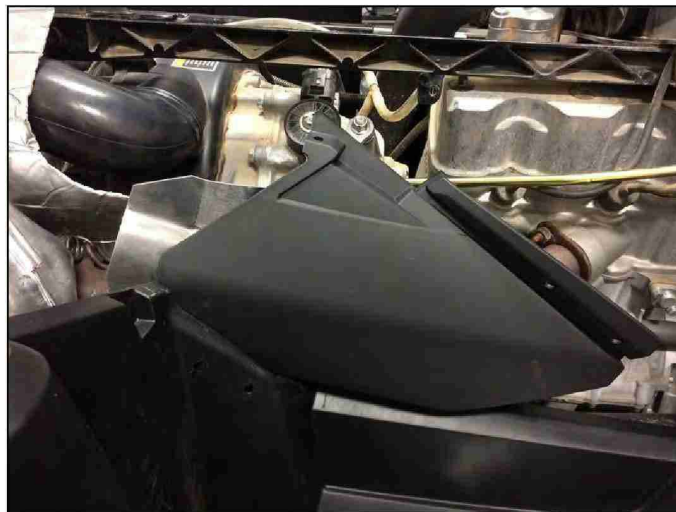
7. Pull the upper rear of the footwell towards the right side of the vehicle, then slide the NEW exhaust manifold side panel (2636626) along the head pipe and release the footwell.

A secondary dealer representative must verify the new exhaust manifold side panel (2636626) has been installed and the original exhaust manifold side panel has been discarded.

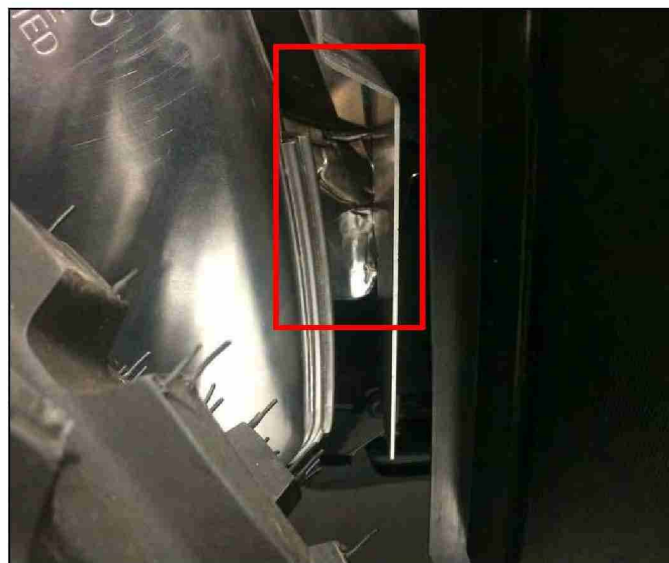
The clutch heat shield should be between the silencer and the clutch cover, as well as the speed sensor. You can view the shield from the right rear wheel well. The heat shield should be the only visible component between the exhaust and the footwell shield.

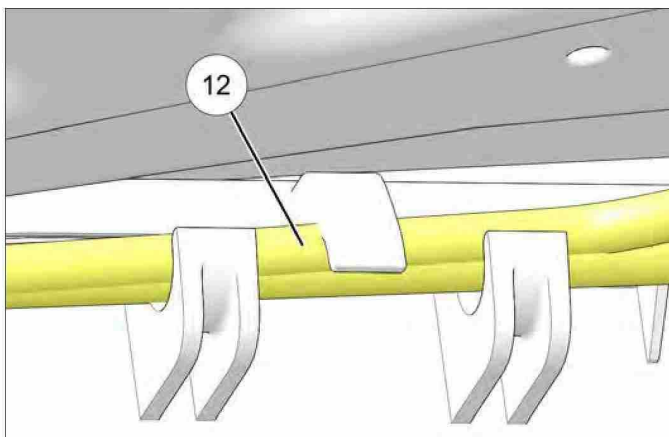
11. Ensure taillight harness ⑫ is properly retained by the clasps on both sides of the rear storage compartment.

A secondary dealer representative must verify the taillight harness ⑫ is properly retained by the clasp as shown and the shielded tubing is not damaged. If the convoluted tubing or reflective tape is damaged, take photos of the affected components and submit an ASK Polaris case for review by Tech Service.

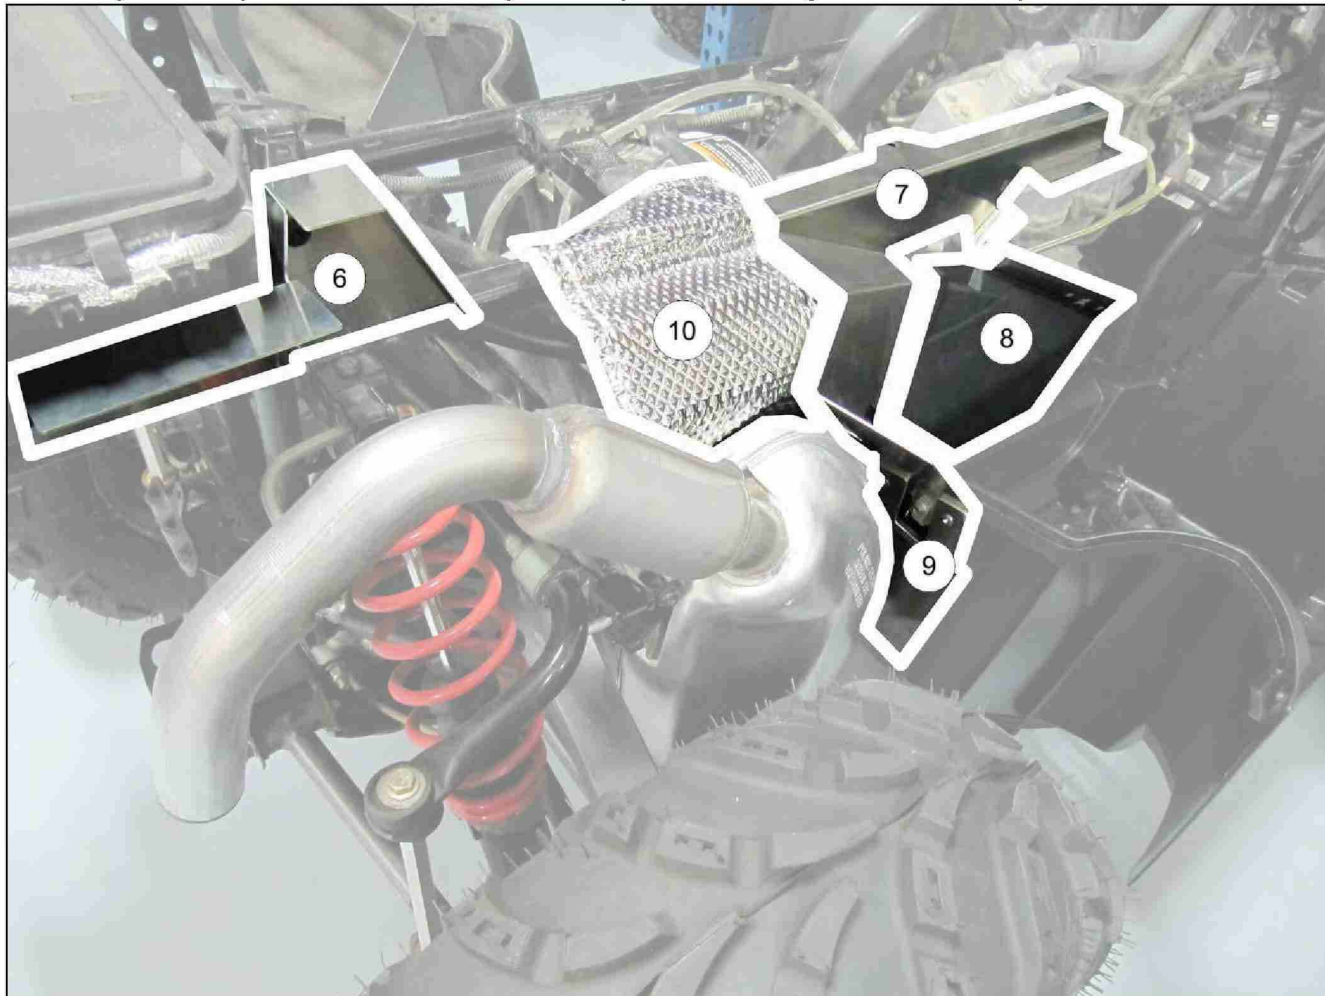
12. Take a picture from just above the right rear wheel, pointing toward the center of the machine. Ensure that all heat shields/foils installed are visible. This is one of two pictures required to submit the warranty claim.

A secondary dealer representative must verify that the picture taken aligns with the example and all shields are visible.

⑥ Rack Support Heat Shield	5264561
⑦ Front Cab Heat Shield	5264561
⑧ Exhaust Manifold Side Panel	2636626
⑨ Footwell Heat Shield	5264564
⑩ Clutch Duct Heat Shield	5264700

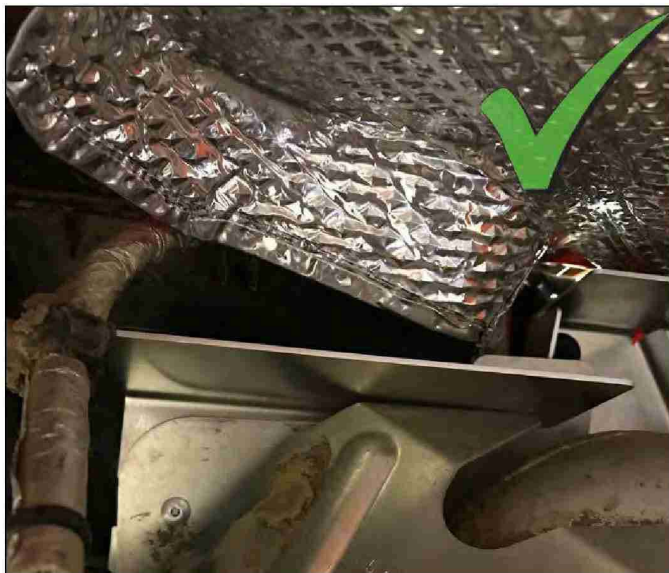
A secondary dealer representative must verify the Rear Cab Heat Shield is bent down and wraps around the corner of the Storage Box and Tail Light Harness. If it interferes when installing the cab, ensure it is bent back down to match the good example below.

Acceptable – Rear Cab Heat Shield encloses the corner of the storage box and harness

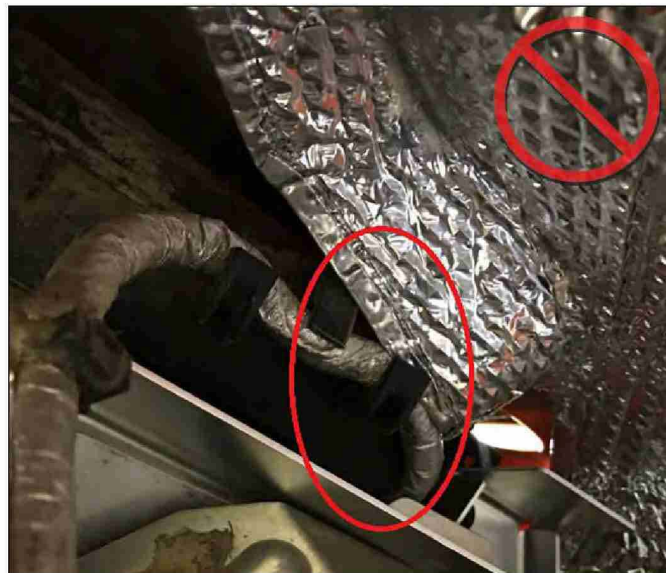
Unacceptable – Rear Cab Heat Shield interferes with the storage box and harness

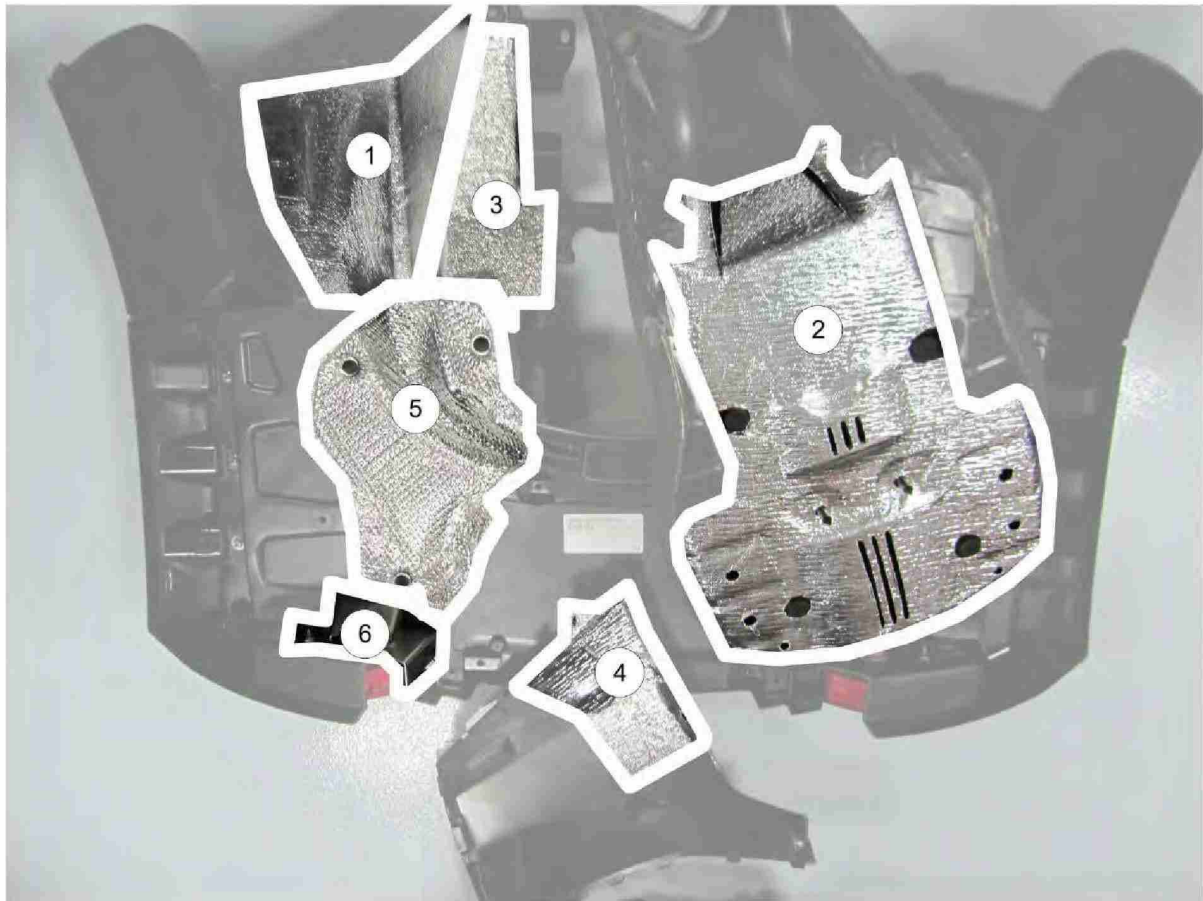
**PHOTO 1 - 1000 1-UP - New Thermal Protection Foils**

① Existing Rear Cab Foil	<b>DO NOT REMOVE!</b>
② Seat Heat Shield Foil	5814630
③ Rear Cab Heat Shield Foil	5814631
④ Side Panel Heat Shield Foil	5814632
⑤ Rear Cab Heat Shield	5263209
⑥ Tail Light Heat Shield	5264567

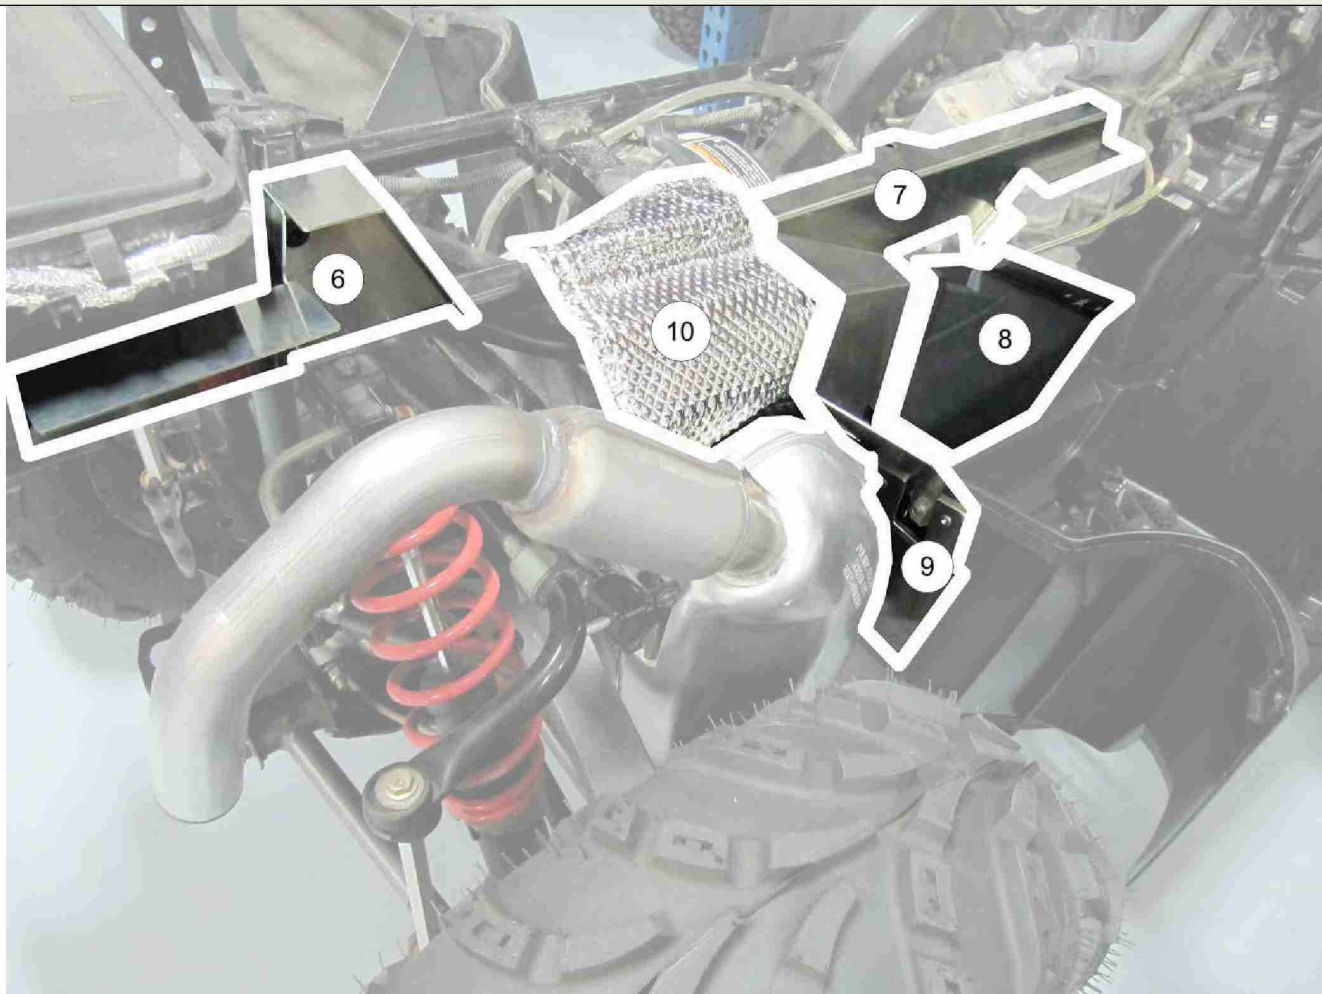
**PHOTO 2 - 1000 1-UP - New Heat Shields**

⑥ Rack Support Heat Shield	5264561
⑦ Front Cab Heat Shield	5264561
⑧ Exhaust Manifold Side Panel	2636626
⑨ Footwell Heat Shield	5264564
⑩ Clutch Duct Heat Shield	5264700
